Annual Mean Number of Days with Freezing Precipitation for the Chesapeake Bay Watershed Region

To help identify coastal flooding, FEMA will conduct engineering studies referred to as Flood Insurance Studies (FISs). Using the information gathered in these studies, FEMA engineers and cartographers delineate Special Flood Hazard Areas (SFHAs) on flood maps. SFHA are subject to inundation by a flood that has a 1-percent or greater chance of being equaled or exceeded in any given year. This type of flood is commonly referred to as the 100-year flood or base flood. A 100-year flood is not a flood that occurs every 100 years. In fact, the 100-year flood has a 26 percent chance of occurring during a 30 year period, the length of many mortgages. The 100-year flood is a regulatory standard used by Federal agencies and most states, to administer floodplain management programs. The 100-year flood is also used by the NFIP as the basis for insurance requirements nationwide. The FEMA Special Flood Hazard Area designations area associated with the probability of flooding (Table 18):

Middle Peninsula Storm Surge Hazard Maps

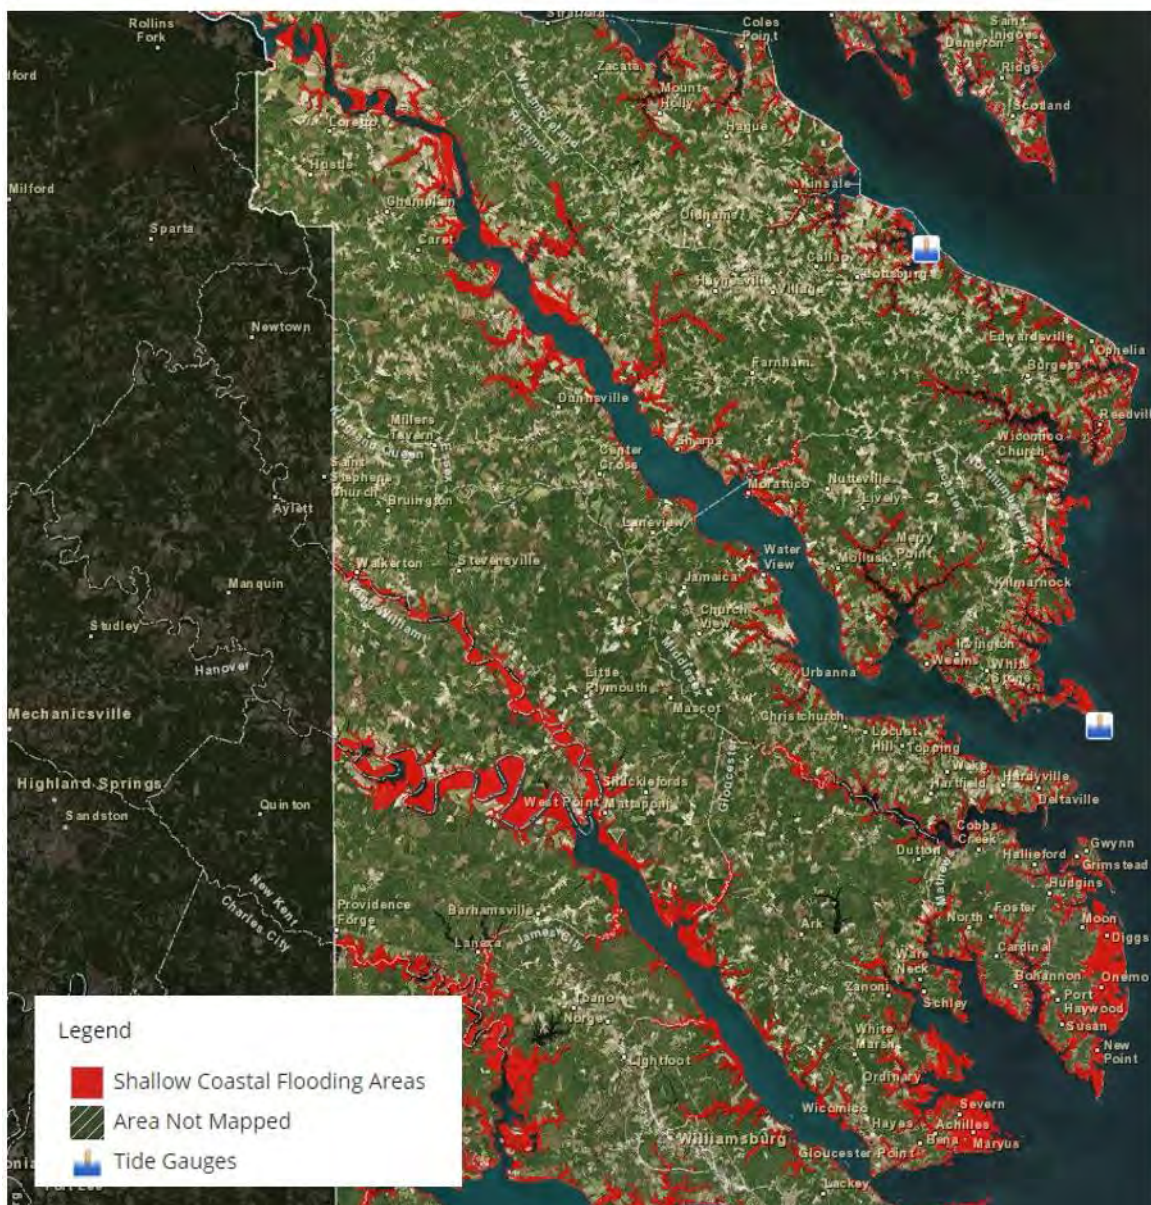
Figure 27:

Frequent Shallow Coastal Flooding in Middle Peninsula Virginia (NOAA, 2015)
